## Test Report

FOR: **dB Sound Control**  
Mt. Airy, NC

**Impact Sound Transmission**  
**RAL-IN18-015**

ON: Laminate flooring over dB Fiber underlayment over 6 in. concrete slab, no ceiling

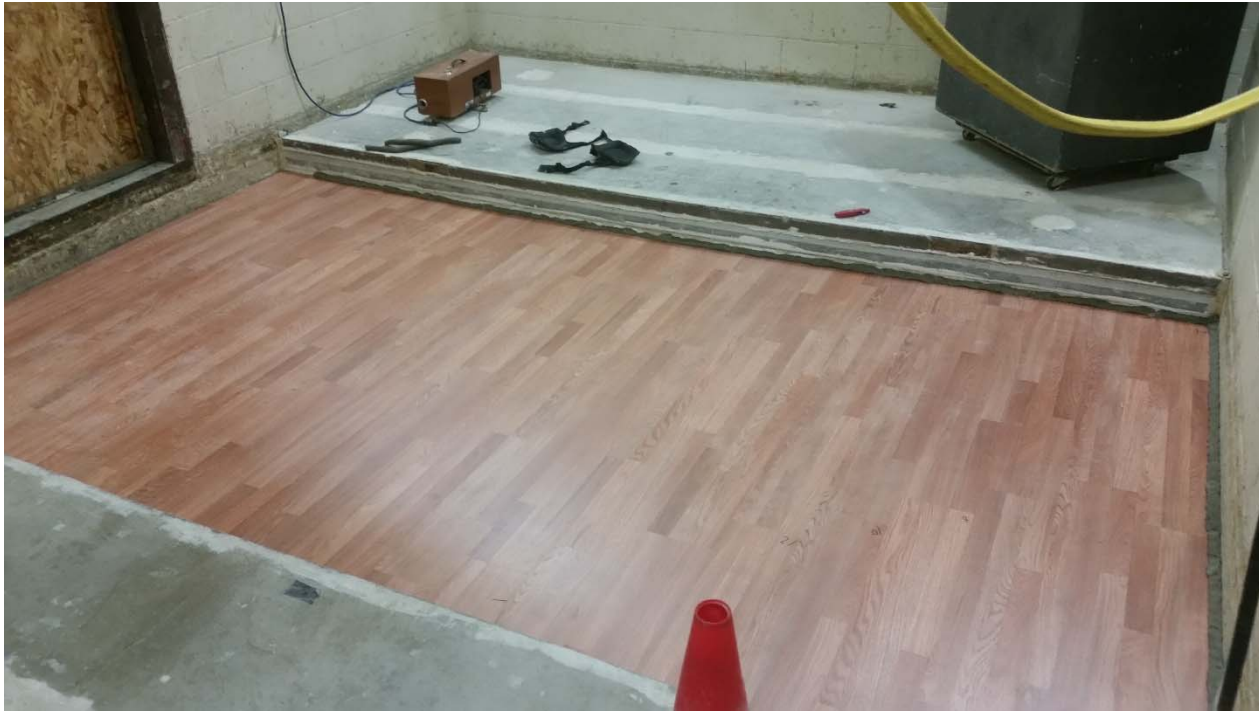
Figure 1 – Specimen mounted in test opening.

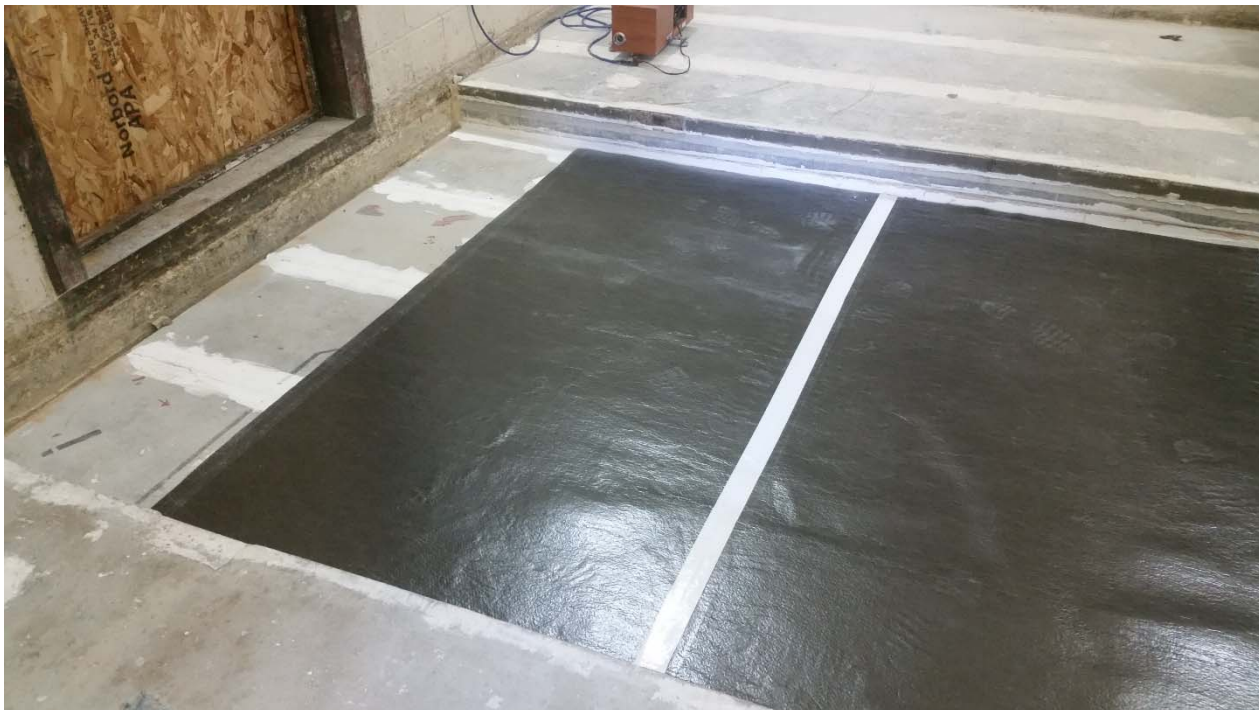
Figure 2 – Underlayment partially installed on concrete slab

Trade Name: dB Fiber  
Material: Felt over clear plastic sheet  
Installed: Loose laid over concrete slab, felted side down  
Overall Dimensions: 2438.4 mm (96 in.) x 2743.2 mm (108 in.)  
Measured Thickness: 3.81 mm (0.15 in.)  
Overall Weight: 52.84 kg (116.5 lbs)  
Mass per Unit Area: 5.08 kg/m<sup>2</sup> (1.04 lb/ft<sup>2</sup>)  
Joints: Sealed with tape

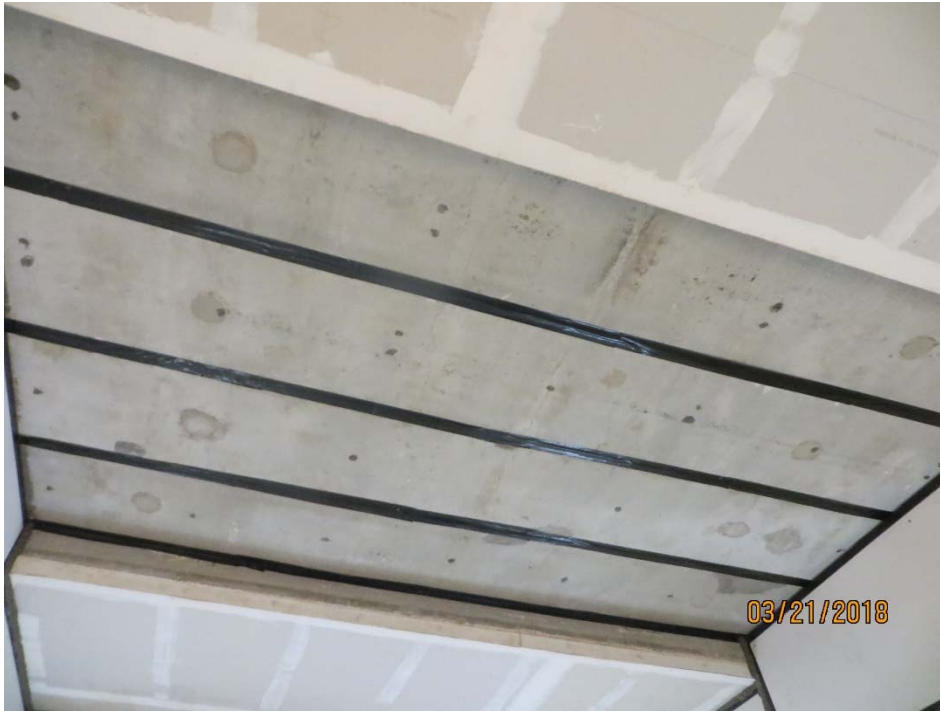
Figure 3 – Underside of test specimen
